# Damage to Ancient Buildings from Earthquakes

Miklós Kázmér\*

Department of Palaeontology, Eötvös University, Budapest, Hungary

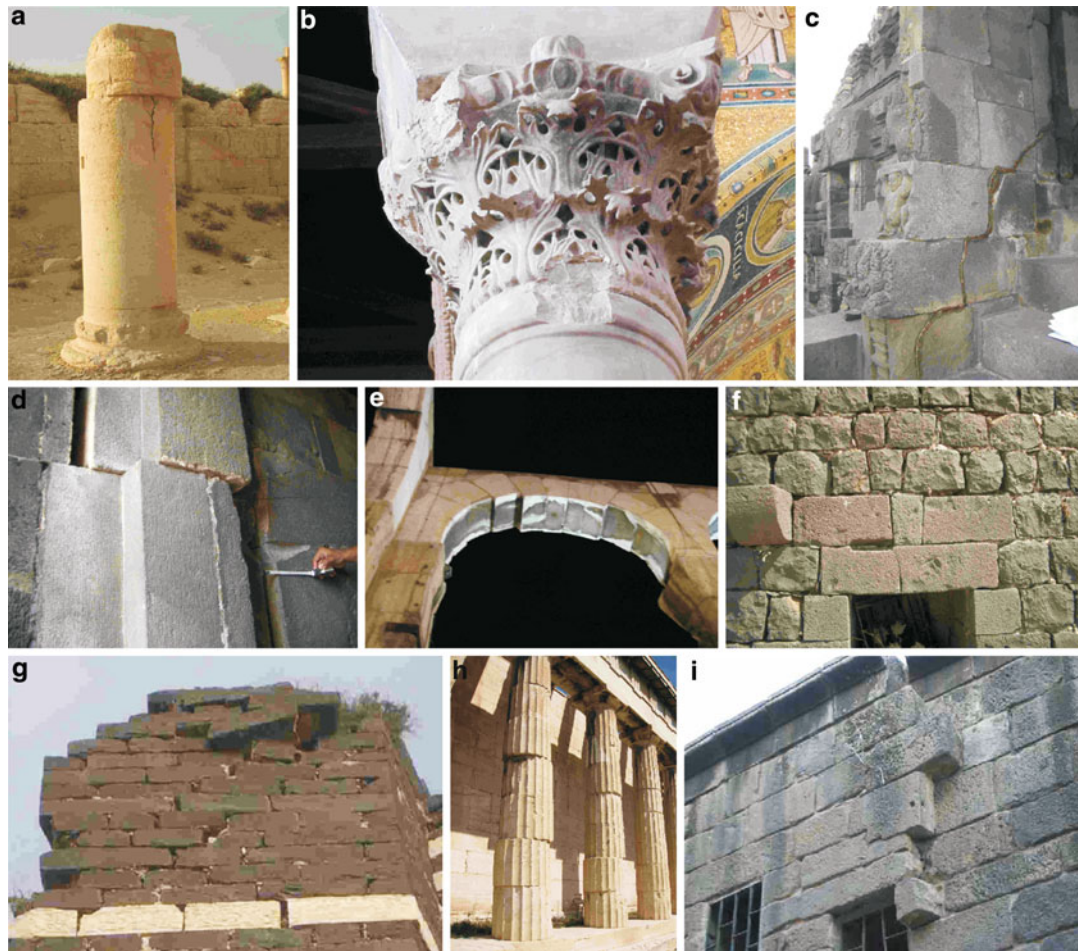
**Fig. 1** Typology of earthquake-induced damages in ancient buildings. (a) Cracks/fractures within a block (second century AD Palmyra theater, Syria). Photo Kázmér #4281. (b) Chipped edges of column and capital in the sixth-century Euphrasius cathedral, (Poreč, Croatia), damaged by the 1440 earthquake #0080. (c) Through-cutting fractures (repaired) in the eight- to ninth-century Brahma temple of the Prambanan complex, Yogyakarta, Indonesia, caused by the 2006 earthquake #6488. (d) Horizontal shift of large ashlars; vertical joints opened up between them. Shiva temple, Prambanan complex, Yogyakarta, Indonesia. Tape measure extended 20 cm #6498. (e) Dropped ashlars in a Roman arch (Damascus, Syria) #2017. (f) Broken lintels in twelfth-century al-Marqab citadel, coastal Syria #4663. (g) Clockwise-rotated blocks in twelfth-century al-Marqab citadel, coastal Syria #5168. (h) Displaced drums of masonry columns of the fifth-century BC Hephaisteion temple, Athens, Greece #1132. (i) Extruded portion of house wall. Bosra, Syria #4183

The vertical component of a seismic wave moves masonry blocks (ashlars or columns) rapidly up and down. The hammering effect of the upper block on the lower one yields cracks in either or both blocks (Fig. 1a). Penetrating cracks allow a chip, corner, or edge to be separated from the block (Fig. 1b). The direction of the crack is influenced by the lithology of the rock and shape of the block and by direction of hammering. Chipping is not to be confused with rounding or peeling due to weathering as seismically broken chips have sharp edges.

Fractures cutting through two or more blocks are often oriented close to vertical, this being the weakest plane to resist bending forces (Fig. 1c). Fractures through individual blocks are more or less connected to each other, resulting from sudden seismic shaking.

The most common in-plane failures are *gaps* between shifted blocks (Fig. 1d), produced by lasting vibrations acting parallel to the wall. Cracks can develop across single or multiple blocks, even across whole walls. Brick walls display *diagonal cracks* near doors and windows. Masonry walls – dressed stones being significantly larger than bricks – generally do not display this feature.

*Dropped keystones* in arches are widely held to be the most reliable evidence of earthquake damage (Kamai and Hatzor 2008) (Fig. 1e). These are formed during horizontal shaking, if there is no significant vertical load (i.e., when higher parts of the building have already collapsed). In multistory buildings, arches in upper floors get damaged, while lower floors do not exhibit damaged arches. Significant vertical loading tends to hold masonry blocks together through high friction at interfaces.

*Broken lintels* (Fig. 1f) and thresholds occur widely. These features are not firm evidence for seismic shaking because differential settlement of walls due to inadequate foundation can also produce similar structures.

Common out-of-plane failures are *rotated blocks* (Fig. 1g), whose angle or rotation (clockwise or counter clockwise) reflects the direction of strong motion and the friction between adjacent blocks.

*Displaced drums* in rows of masonry columns (Fig. 1h) are products of either in-plane or out-of-plane seismic loads. Both shifting and rotation of drums occur. Historically, the observation of aligned, fallen monolithic columns has been used to infer directions of earthquake epicenters. However, this interpretation is erroneous, since column alignment in fallen structures can also be produced by heavy storms acting on deteriorated buildings (Ambraseys 2006).

*Extruded blocks* (Fig. 1i) indicate loads at a high angle to a wall. Displacement occurs along a more-or-less irregular pattern of masonry blocks (mostly without through going fractures), reflecting the failure of the wall core. Masonry maintains coherence during displacement, indicating that not the mortar between blocks but mortar between wall and core maintains wall integrity.

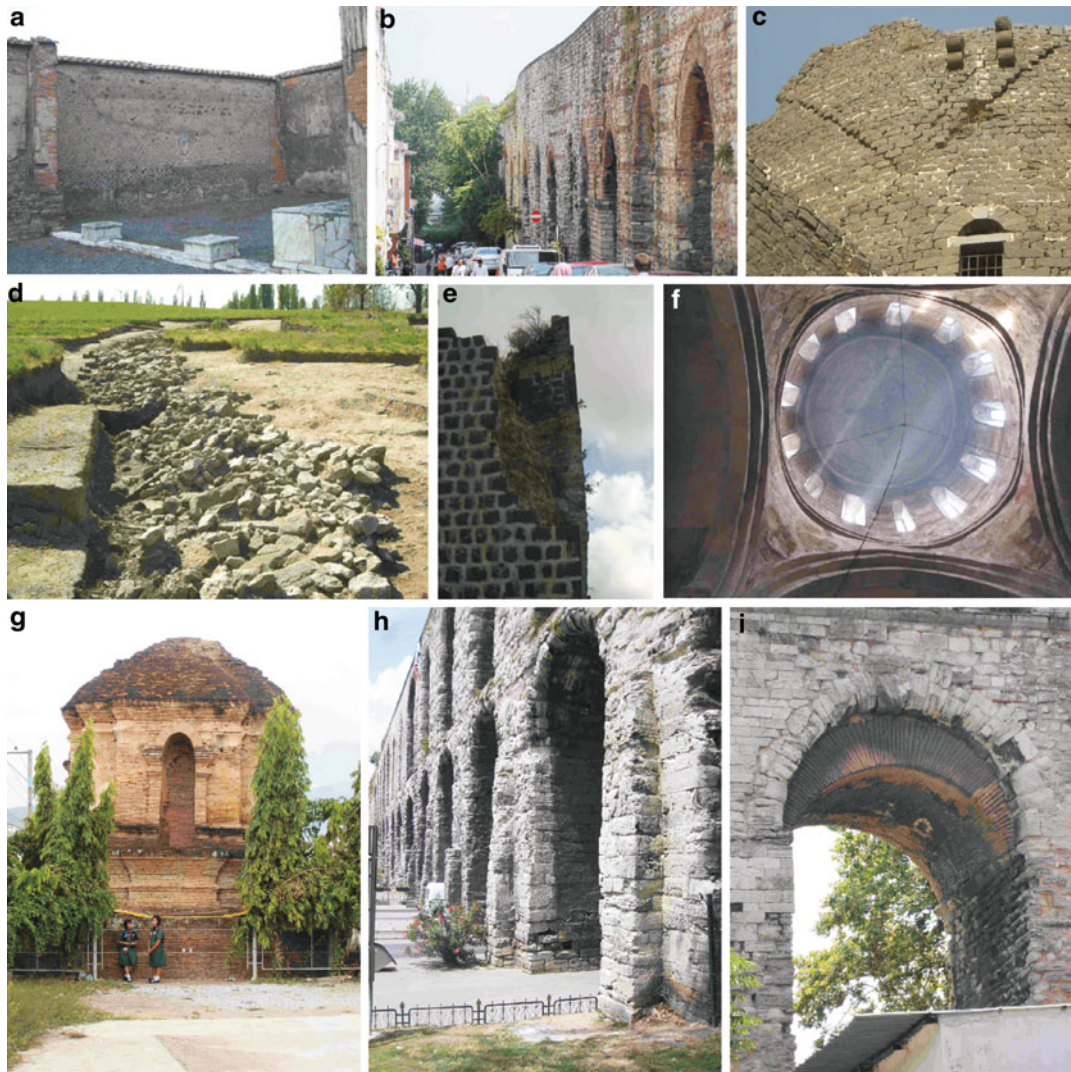
**Fig. 2** (a) Arcuate out-of-plane collapse in the market, Pompeii, Italy, repaired before the 79 AD eruption of Vesuvius, which buried the city. Photo: Kázmér #9266. (b) Warped northern side of the Valens aqueduct (Istanbul, Turkey). Completed in 368 AD, several subsequent earthquakes left their traces on the massive construction #0340. (c) V-shaped damage on the SW wall of the twelfth-century donjon of al-Marqab citadel, coastal Syria. The damage was inflicted by the 1202 earthquake (Kázmér and Major 2010) #4589. (d) Fallen masonry fence in the Roman city of Carnuntum (Deutsch-Altenburg, Austria) #5496. (e) Triangular missing parts in corners of walls (al-Marqab citadel, coastal Syria) #4671. (f) Deformed circular dome of fourth- to eleventh-century Samtavro cathedral, Mtskheta, Georgia #1633. (g) Tilted Buddhist stupa (approximately fifteenth century) in Chiang Mai, Thailand. While a single tilted building does not indicate seismic origin, this stupa is one of 21 sites displaying tilting in the city (Kázmér et al. 2011) #3411. (h) Buttresses support the pillars of the Valens aqueduct in Istanbul, Turkey, completed in 368 AD #0335. (i) Valens aqueduct in Istanbul, completed in 368 AD. A brick arch was built to support the weakened stone arch after one of the frequent earthquakes in the region (Istanbul, Turkey) #0335

The *arcuate collapse* of walls (Fig. 2a) is sign of loads acting at high angle to a wall that is confined (fixed) at both ends. Wall terminations (usually supported by cross walls) maintain their full elevation, while the free-standing middle part loses coherence and collapses during heavy vibration.

A *warped wall* is produced by out-of-plane loads acting at high angle to the wall (Fig. 2b). Warping can be to one or both sides. Thick walls made of Roman concrete can behave this way,

while thin walls collapse in arcuate form (Fig. 2a). Generally, there is no change of wall geometry at foundation level.

A *V-shaped extrusion* near the top of a cylindrical building (Fig. 2c) indicates strong motion in the direction of extrusion.

*Fallen walls* lying on the ground are more-or-less preserving original coherence (Fig. 2d). A seismic load acting at a high angle to a wall can cause simultaneous collapse along the full length of the structure.

*Triangular collapses* in the corners of walls (Fig. 2e) are due to differential loading of perpendicular walls. Shaking in different directions at the same time shears off the masonry joints, allowing collapse of the weakened corner.

Simple *deformed geometrical structures deformed* (rectangular to parallelogram, circular to elliptical, etc.) (Fig. 2f). These features are hard to recognize, since deformations are subtle: parallels and right angles deviate a few degrees only (higher deformation would yield total collapse).

*Tilted buildings* are signs of uneven loading of subsoil (Fig. 2g). When seismic vibrations act on water-saturated soil, it loses coherence and behaves like a fluid. Building foundations – losing support during liquefaction events – suffer differential settlement, tilting, and collapse. Traces of total failure are mostly removed, but minor tilting – not affecting the use of the building – is often left unrepaired.

Ruins of completely collapsed buildings are usually removed after an earthquake. Moderate damages are repaired on the spot, and additions, new walls, *buttresses* (Fig. 2h), *reinforced arches* (Fig. 2i), and other *supporting structures* can be identified as evidence of past earthquakes. Repairs are often built of different, often inferior material (Fig. 2i: brick arc supporting a stone arch), poorly fitted to masonry patterns, obstructing windows – these are features of repair following structural damage.
