Geological features in ancient buildings – archaeoseismology

In: Mukherjee, S. (ed.) (2015): Atlas of Structural Geology. Elsevier, Amsterdam, pp. 153-155, figs 6.52-6.55.

Miklós Kázmér
Department of Palaeontology, Eötvös University
Budapest, Hungary
mkazmer@gmail.com

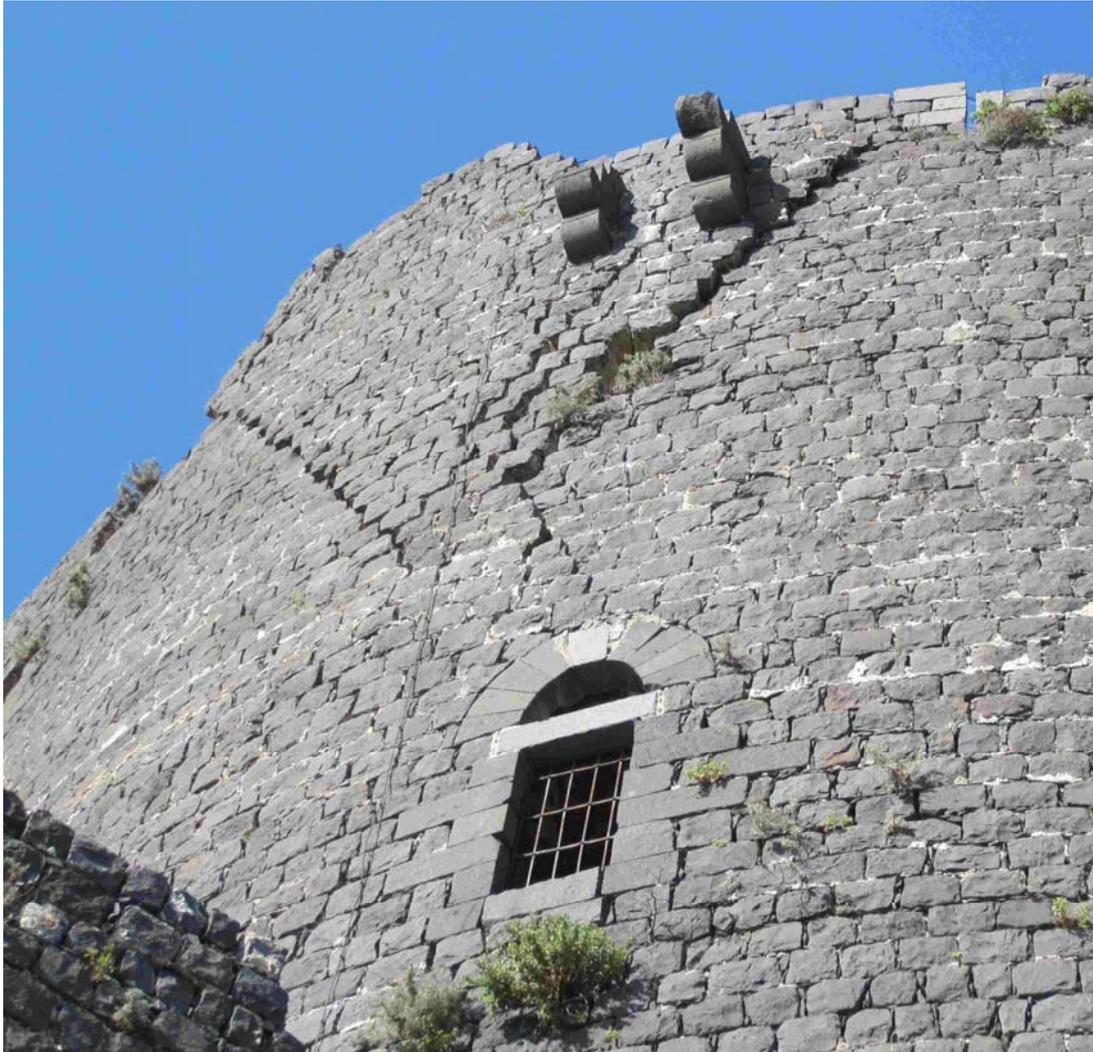
Fig. 6.52. **V-shaped, extruded block bordered by conjugate faults.** A wedge-shaped block of masonry, ca. 7×7 m, shifted toward 240° azimuth by ~ 20 cm during the largest known earthquake in the Near East, in 1202 AD. Donjon of al-Marqab citadel, Syria, built by the Hospitaller knights in late 12th century. Built of Roman concrete (rubble in lime), the external and internal walls are faced by dressed basalt blocks. Walls are up to 5 m thick, diameter of the tower is 20 m. Between floors – where the extruded wedge is – the building is compact. Al-Marqab, south of Baniyas on the Mediterranean coast, Syria ($35^\circ 09' N$, $35^\circ 56' E$). Photo #1798.

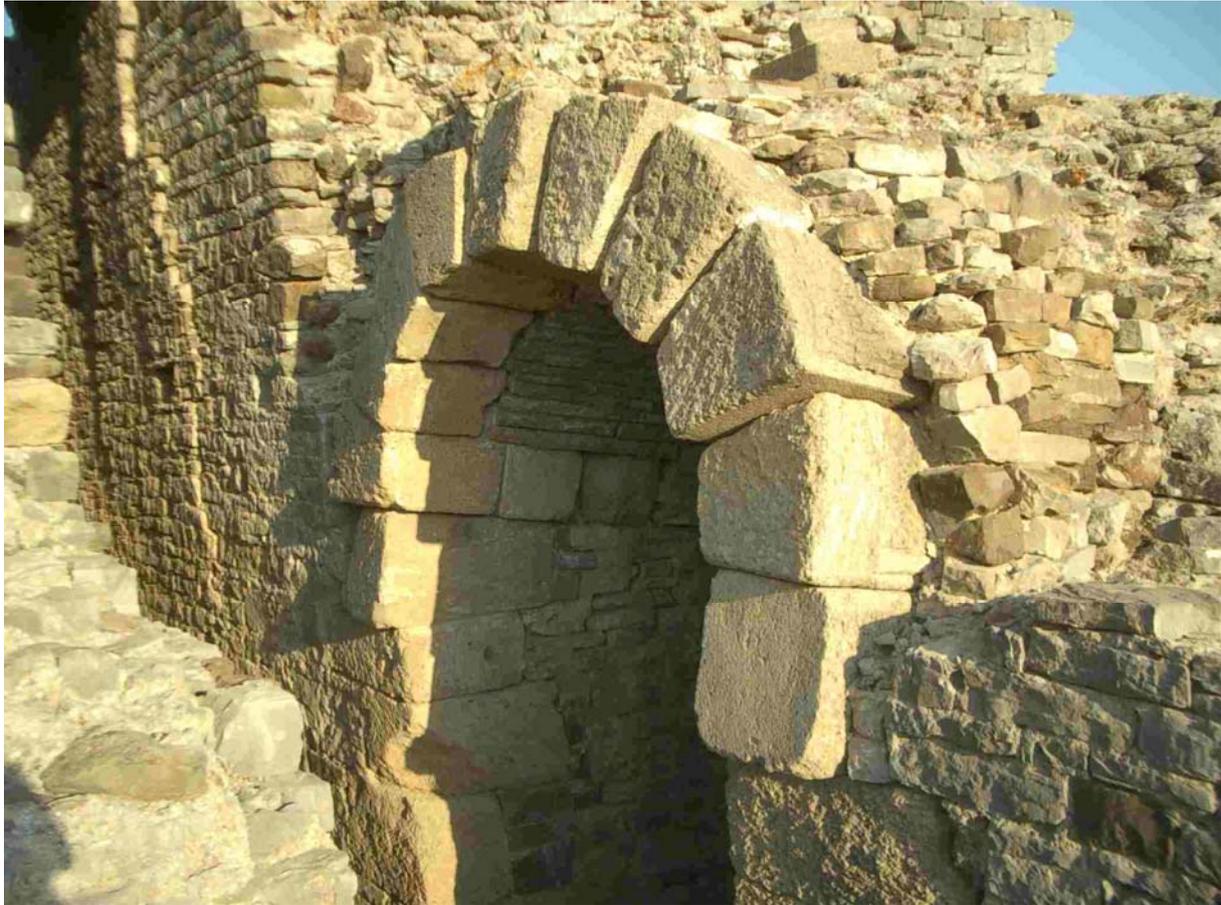
Fig. 6.53. **Distributed left-lateral strike-slip deformation** in the Roman theatre of Baelo Claudia, Gibraltar Straits, Spain (36° 05' N, 5° 46' E). There are conspicuous displacements visible on the wall of the staircase and between the blocks forming the arch in the foreground. Displacement is larger upwards (max. 10 cm), indicating seismic shaking: the top part of the building oscillated with higher amplitude than the lower part, attached to the foundation.

The town along the northern coast of Gibraltar Straits, flourished during 1st to 4th century AD. After an earthquake of intensity IX-X MSK about 350-395 AD the city was abandoned. Active faults nearby and a landslide within the area of the Roman town contributed to the damages. Scale: stairs on the left are 20-25 cm high. Photo #8375.

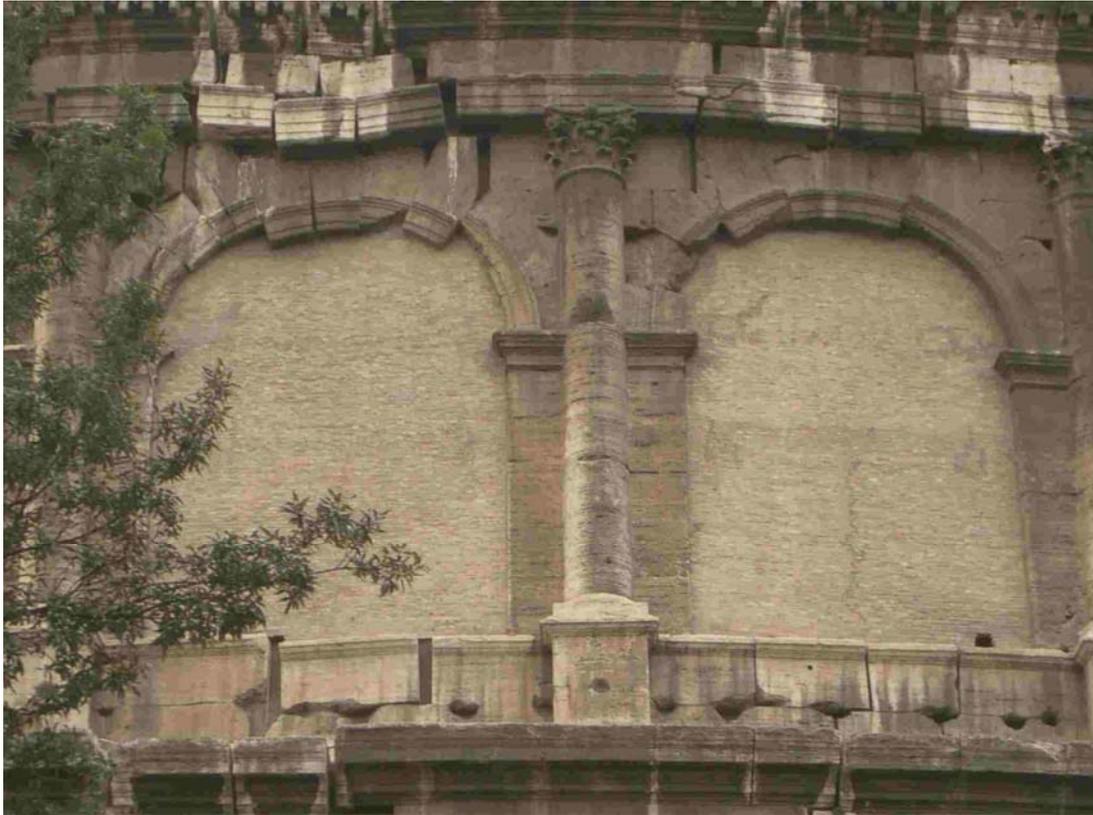
Fig. 6.54. **Dropped keystones and adjacent blocks in the arches of the Colosseum, caused by earthquake shaking.** The feature is a miniature analogue of rifting: extension produced open fissures, normal faulting, subsidence and tilting of blocks.

The Flavian amphitheatre in Rome, Italy, (worldwide known as Colosseum) was built between 70 and 76 AD ($41^{\circ} 53' N$, $12^{\circ} 29' E$). The external wall is composed of travertine blocks originally connected by iron pins and cramps embedded in lead, without mortar. Holes of uniform size between the blocks were made to steal the lead in times of scarce supply. Several earthquakes between 508 AD and 1703 AD affected Rome and the Colosseum. Heterogeneity of the soil beneath the foundations (lake sediments below the northern part as opposed to an abandoned bed of the river Tiberis below the southern part) yielded uneven vibration and settlement during earthquakes. This is why the southern perimeter wall of the Colosseum collapsed. The photo shows severely damaged arcades #23 and #24 between the collapsed and intact portions of the external wall on the eastern end of the amphitheatre. These were closed by a brick wall during a restoration effort in 1805-1807, preserving the arches in their damaged form. Photo #9338

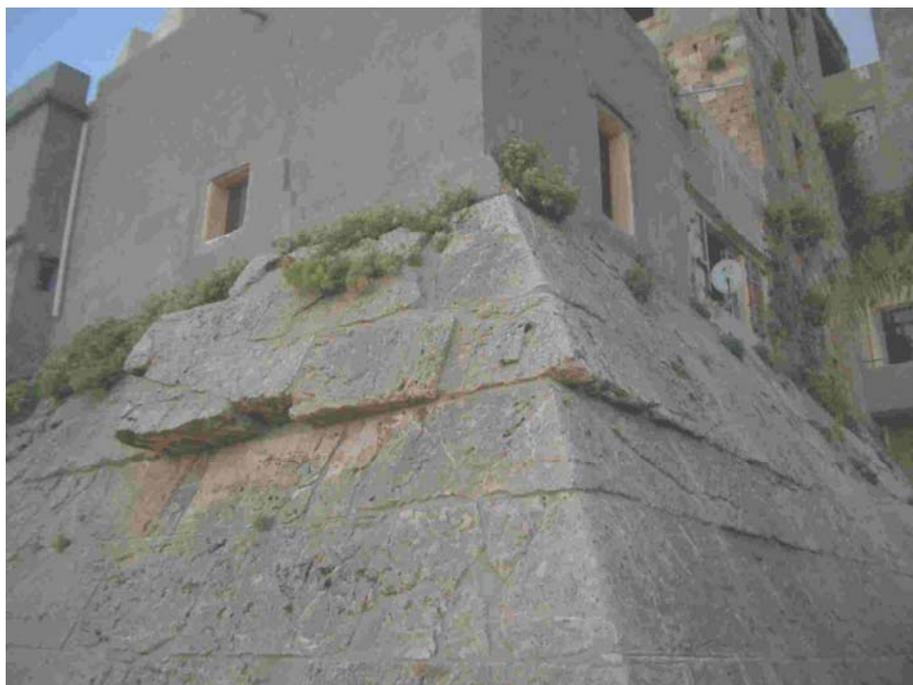
Fig. 6.55. **Rotated blocks** within the sea wall of the crusader castle, Tartous, coastal Syria (39° 53' N, 35° 52' E). The fortress, built in the 12th century by the knights of the Temple, suffered the greatest damage probably during the 1202 AD earthquake. Blocks are ca. 70 cm high. The counterclockwise rotation of four blocks together (left block towards the viewer) was caused by E-W strong seismic motion. There is a right-lateral strike-slip fault on the northern side of the leftmost blocks. Vertical component of seismic waves allowed the blocks to rotate when the overburden was momentarily relieved, and seismic loading overcame friction. Photo #4682.
