Evidence for earthquake damage on St. Michael church in Cluj-Napoca, Romania

Abstract: A preliminary archaeoseismological study carried out on St. Michael church in Cluj-Napoca, Romania, revealed various deformations which can be attributed to earthquakes. There are both in-plane and out-of-plane deformations, including dropped keystones, shifted masonry, folded walls, etc. Probably the earthquake of 1763, recorded in historical documents, is responsible for at least part of the damage. The archeo-intensity scale assign at least $I = VII$ for dropped keystones, and $I = IX$ for displaced masonry. These values for the Gothic church in Cluj well exceed the postulated 475-year recurrence intensity $I = VI$ for the region.

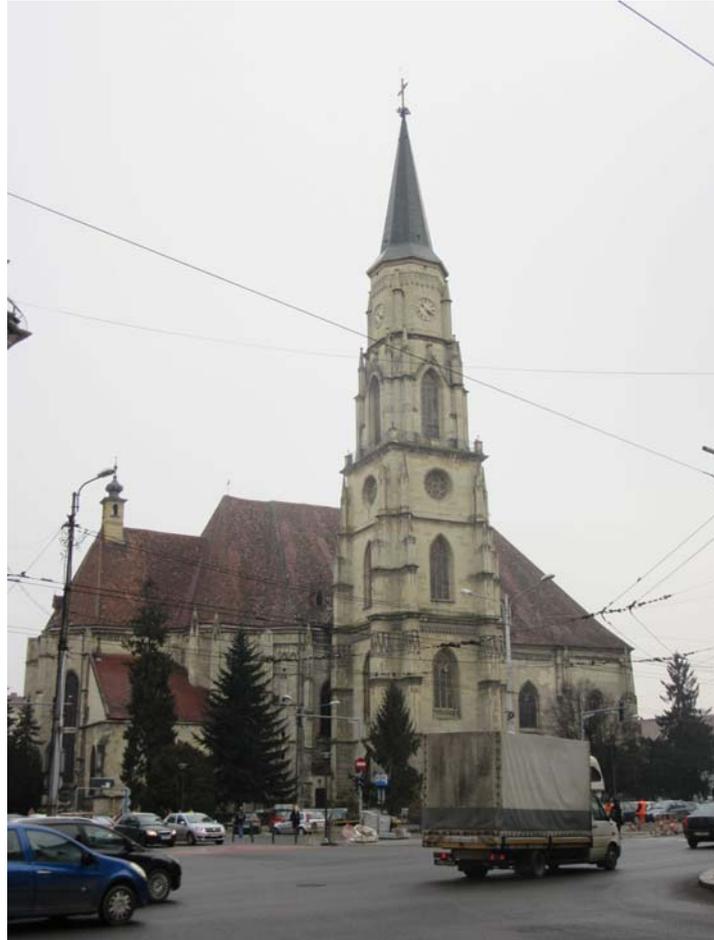
Fig. 1 - St. Michael church in the main square of Cluj-Napoca. Built in the late Middle Ages, the naves are Gothic. The tower is a 19th century replacement of the original tower destroyed by the 1763 earthquake. Photo Kázmér, #1049.

The church history monograph of Sas (2009) mentions the 1763 earthquake, which damaged the Medieval tower beyond repair. The Réthly (1952) and Zsiros (2000) earthquake catalogues do not mention this event.

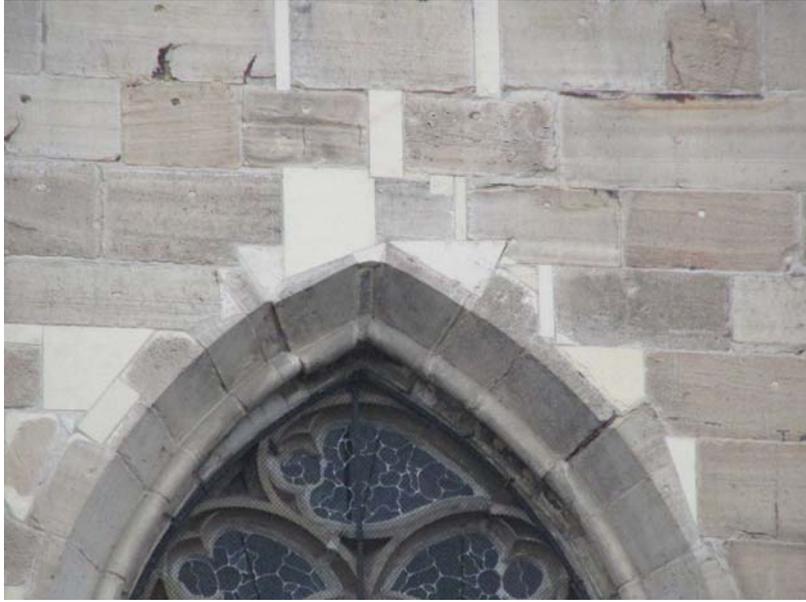
Fig 2 -.Dropped stones of the tipped arch of a Gothic window. One block on the left and three blocks on the right dropped downwards by a few centimetres during in-plane shaking of the building. White blocks are newly inserted stones to fill up empty space between shifted blocks (two upper rows) and irreparably broken blocks surrounding the window. Photo #1074

In-plane deformations (parallel with the church wall) are shifted masonry: there are (1) damaged and dropped keystones of Gothic windows (Fig. 2); (2) gaps up to 20 cm width between adjacent blocks (Fig. 3); (3) vertical fractures separating stone block into two parts (Fig. 4), etc. Out-of-plane deformations (at an angle with the wall) are (4) rotated masonry blocks in the sanctuary wall (Fig. 3), (5), and the folded wall of the nave (Fig. 5). All displacements are near the top of 17 metres high the church wall, in close proximity to the roof.

The Rodriguez-Pascua et al. (2013) archeo-intensity scale assign at least $I = VII$ for dropped keystones, and $I = IX$ for displaced masonry. These values for the Gothic church in Cluj well exceed the postulated 475-year recurrence intensity $I = VI$ for the region (Leydecker et al., 2008).

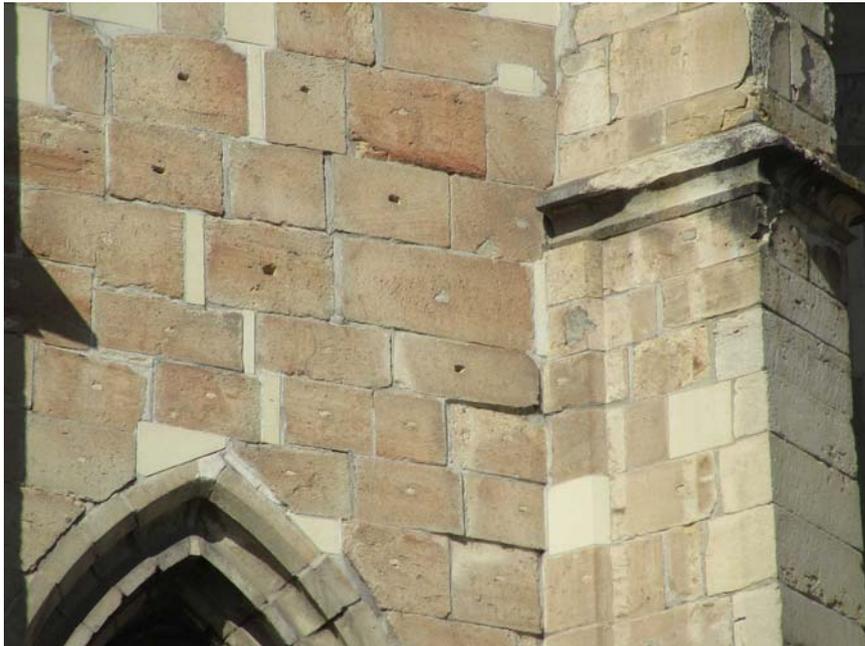
Fig 3 - Repaired traces of in-plane shift of adjacent masonry blocks (white fillings) above the Gothic window. A block adjacent to the supporting pilaster to the right has been rotated clockwise relative to the plane of the wall: its right edge is several centimetres towards the viewer. Photo #1127

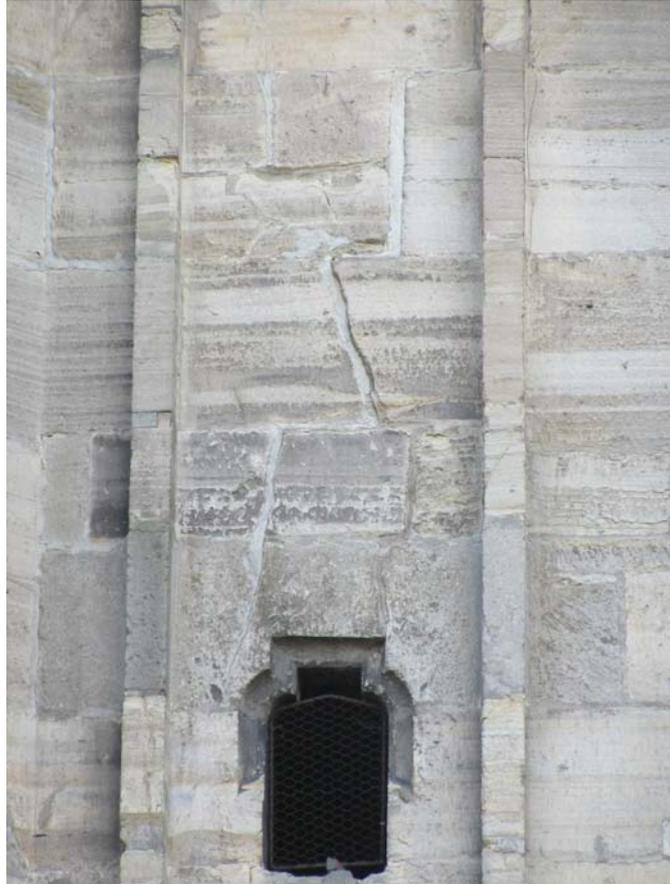
Fig. 4 - Broken ashlar in the middle of the picture window lintel broken twice. Repaired traces of stone blocks shifted in-plane. Wall of the southern aisle, window into a staircase. Photo #1139

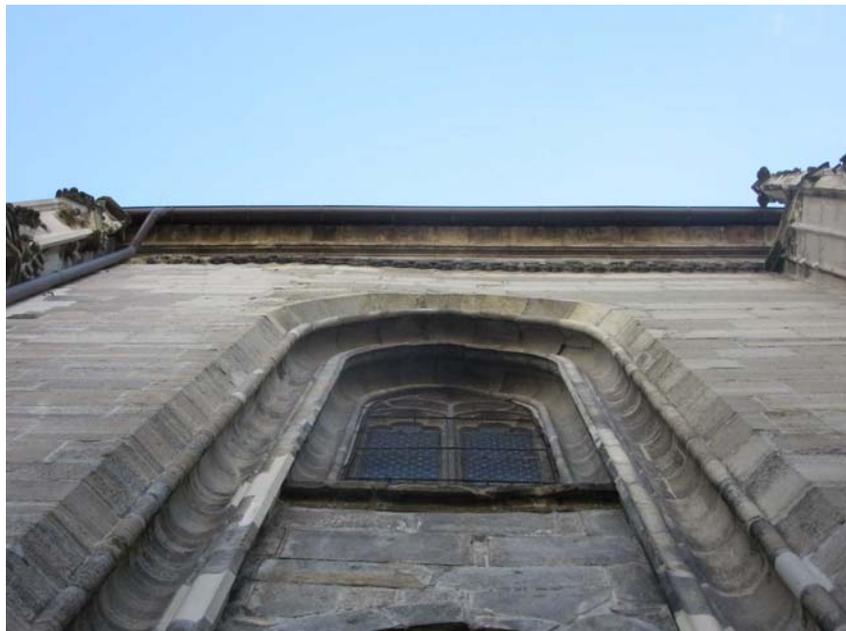
Fig. 5 - Southern wall of the apse: the upper portion above the window suffered an out-of-plane displacement. The part on the left moved towards the viewer by more than 10 centimetres. It is not a construction error: it is due to intensive shaking, perpendicular to the plane of the wall. Photo #1151
