## Damages to the 9<sup>th</sup> century Prambanan temple caused by the 2006 Yogyakarta earthquake (Java, Indonesia)

**Abstract:** An M 6.5 earthquake hit Yogyakarta on May 26, 2006. The region, considered aseismic, suffered high damages: 155,000 houses were destroyed. The Prambanan temple complex was among the severely damaged masonry buildings. Location and direction of damages have been investigated: displacement and falling directions of masonry blocks were surveyed. We reconstructed the direction of strong motion responsible for the damages. It is parallel to the strike of the causative fault (30°-210°).

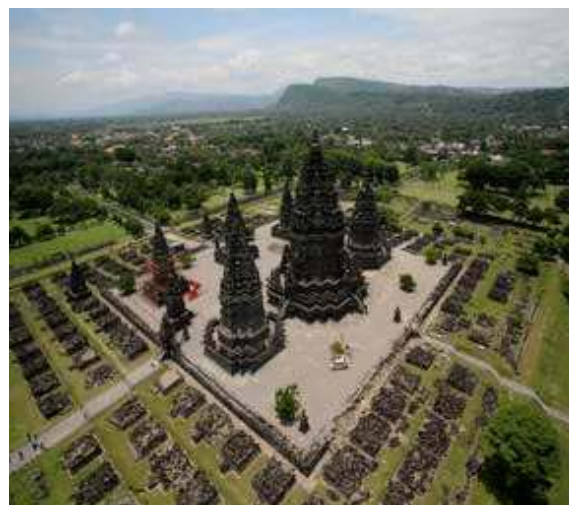
Fig. 2: Aerial view of the Prambanan temple complex.

The Loro Jonggran temple complex (mentioned by the better-known name of the village Prambanan where it is located) was probably built during the first half of the 9th century (Fig. 2). The pervasive Hindu cultural influence and rule erected a multitude of temples at that time, including the UNESCO World Heritage site Borobudur 35 km to the NW. Prambanan has been a site for cultural and religious tourism (Jordaan, 1996) since its discovery by Sir Thomas Raffles, the then British governor of Java during the Napoleonic wars (Raffles,

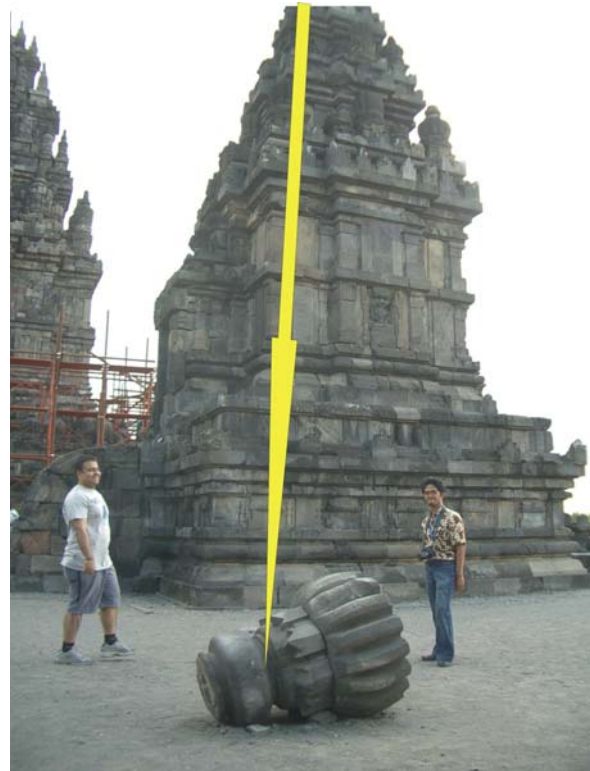
Various damages were surveyed to determine the direction of the strong motion responsible for the displacement. The tip of the 14 m high Apit Utara shrine fell towards 120° for 7.7 m (Fig. 3) (EAE: impact block mark, I = VI-). The largest shrine, the 60 m high Shiva temple has a reinforced concrete mantle at the middle and upper levels, while the lower level has not been restored extensively. This unreinforced lower part suffered horizontal extension in 20-200° direction (Figs 4-5) (EAE: displaced masonry blocks in walls, I = IX-).

Fig. 3: Tip of Apit Utara temple fell towards 120° for 7.7 m.

The least constraints are those which affected the falling directions of the tips of the Apit Utara and Brahma temples, both temples close to being centrally symmetrical. The top part can fall in any direction as dictated by shaking. Their falling direction is perpendicular to each other; i.e. both regular components of strong motion directions could affect them (Fig. 7).

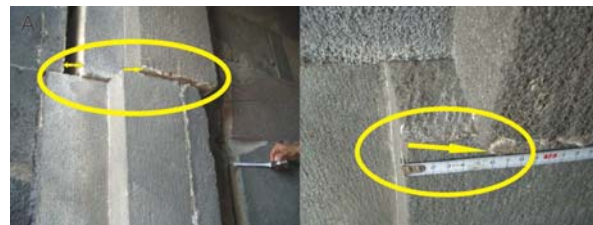
Fig. 4: Shiva temple, sanctuary level. 45 mm shift towards 20°

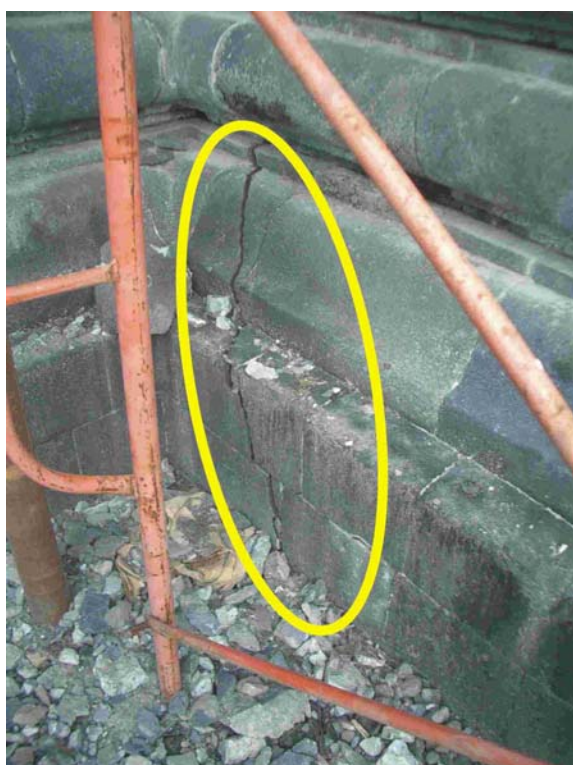
Lower part of the Brahma temple was enclosed in reinforced concrete, while the middle and upper parts were left intact. There are centimetre-sized left-lateral displacements across several rows of masonry in the unreinforced level. We suggest that these are surface features of a left-lateral displacement zone, which runs diagonally across the monument (EAE: penetrative fracture of masonry blocks, I = VII-).

Fig. 6: Brahma temple: a NW-SE left-lateral fault cross-cutting the temple diagonally. A reinforced concrete wall surrounds the level below this floor. There was 4 mm left-lateral displacement.

Left-lateral strike-slip faulting of Brahma temple is also caused by P waves: these created the diagonal fracture across the building according to the Mohs planes. The left lateral displacement has no particular meaning: the shaking stopped at this particular moment. If stopped another second the displacement would have been right-lateral.
