The 4th century Siscia (Croatia) earthquake – archaeoseismological evidence

Miklós Kázmér¹, Rosana Škrgulja²

Kázmér, M., Škrgulja, R. (2021): The 4th century Siscia (Croatia) earthquake – archaeoseismological evidence. In: Lakušić, J., Atalić, J. (eds): Proceedings of the 1st Croatian Conference on Earthquake Engineering, 1CroCEE, Zagreb, Croatia, March 22-24, 2021, pp. 257-266. DOI: <https://doi.org/10.5592/CO/1CroCEE.2021.96>

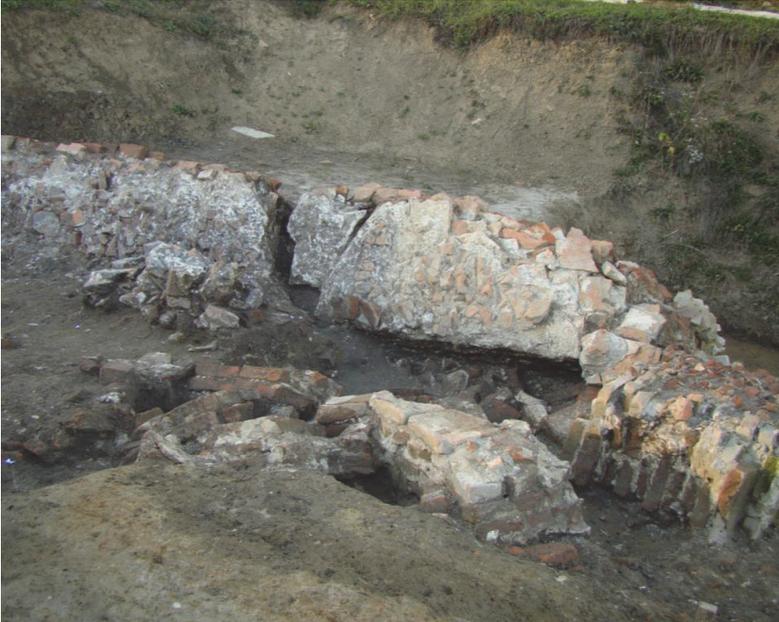
Figure 3. Overturned wall in the moat. The viewer is looking at a mortar layer between rows of bricks, a seen from below(!). Note that in-plane deformation caused a wide gap to appear, marking extension of the wall during shaking or during collapse [37]

Coherent toppled walls are well-known in earthquake-damaged sites in the Mediterranean. A spectacularly similar find is illustrated in [38]: the city wall of Roman Carnuntum, capital of Pannonia Superior province, fell into the city moat. It was a tens of metres long segment, collapsing in a coherent way. Further examples can be seen in Gadara in Jordan [39], in Baeolo Claudia in Spain [40], in El-Lejjun in Jordan [41], or in Oberndorf-Bochingen in Germany [42]. In-plane extension and shift are well documented, among others, extensively in Carnuntum [38, 43, 44].

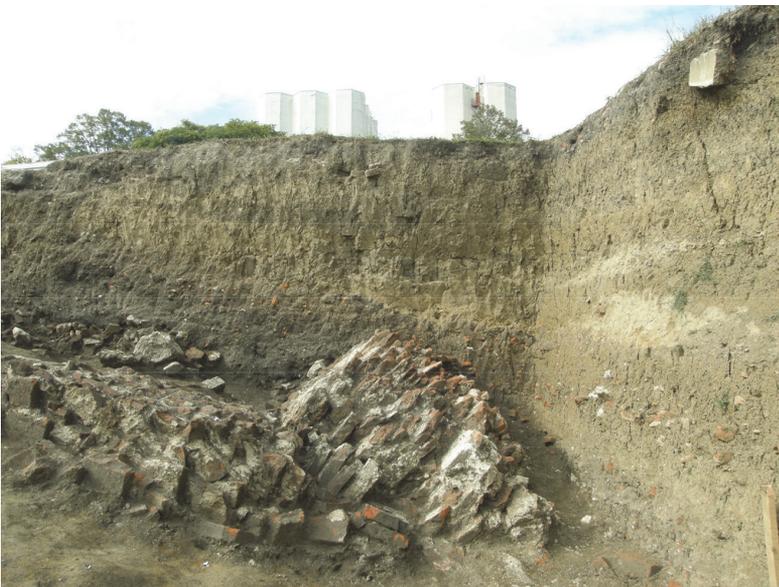
Figure 4. Two portions of a collapsed wall, arranged in different positions. Left block tilted towards the viewer, right block tilted towards west

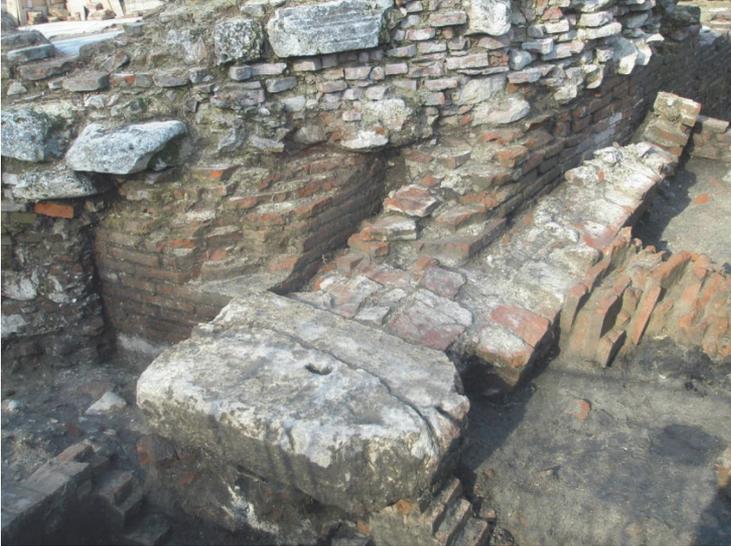
Figure 5. View of the church apse. A tilted wall, next to the early 3th century vertical walls of the Roman entrance complex, on top of which is the 18th century church [19]

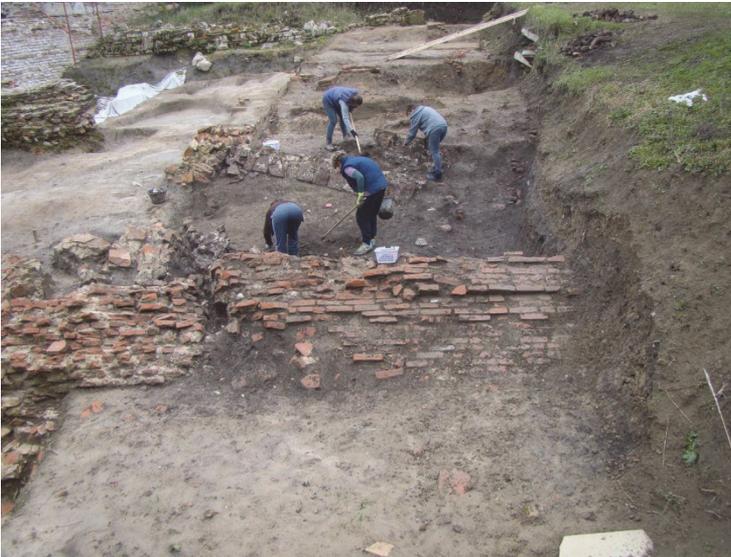
Figure 6. Brick masonry walls collapsed in various directions [37]
